# Manhole Inspection Summary

Manhole # S15A1\_020MH

Insp Date: **6/20/08 2:03 PM**

**Location** Address: **2801 georgetown rd**

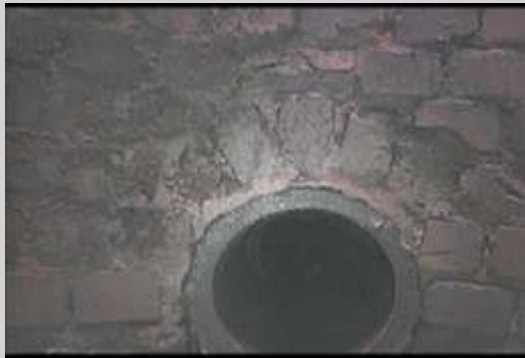
12 O'Clock Outflow

Pipe Height: **8.4** (in.) Rod and Bar (Angled)  
Pipe Material: **Clay** ☐ Pipe Lined  
Invert Depth: **9.30** (ft.) Flow Characteristics: **None**  
Deposits: ☒ None ☐ Mud ☐ Sludge ☐ Debris ☐ Grease  
Silt Depth: **0** (in.) Deposits Extent:  
Infiltration: **None** Pipe Seal Cond: **Sound**

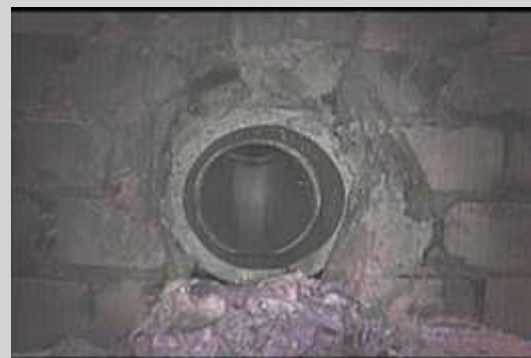
Drop In @ 3 O'Clock

Drop: **Outside** Rod and Bar  
Angled: **Yes** Reading: **7.78** (ft.)  
Inv Depth: **8.78** (ft.)  
Drop Condition: **Open**
